**Sampling Plan for Event 1B  
for the Commencement Bay Nearshore/Tideflats Superfund Site -  
Hylebos Waterway Problem Areas**

**Final Report**

July 7, 1994

Striplin Environmental Associates, Inc.

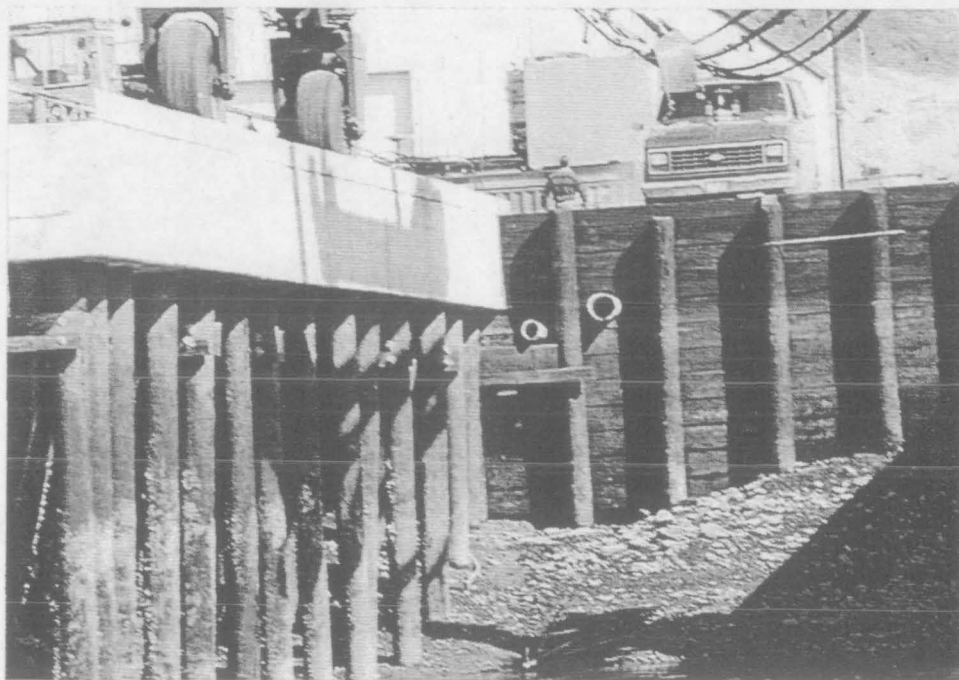
Photo was taken at an estimated tidal height of -0.2 foot

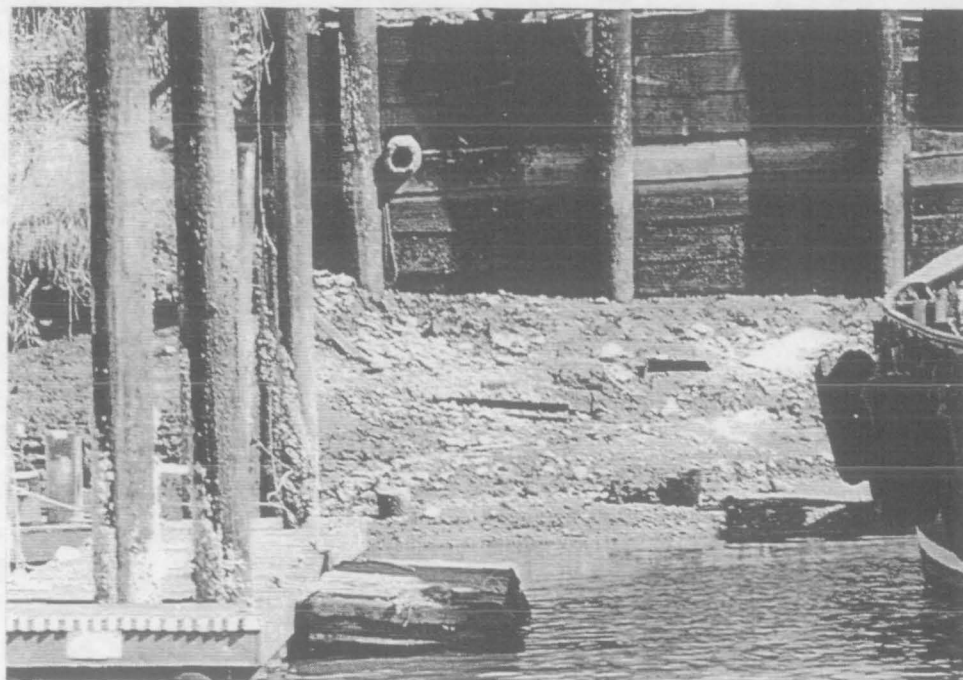
Photo was taken at an estimated tidal height of -0.2 foot

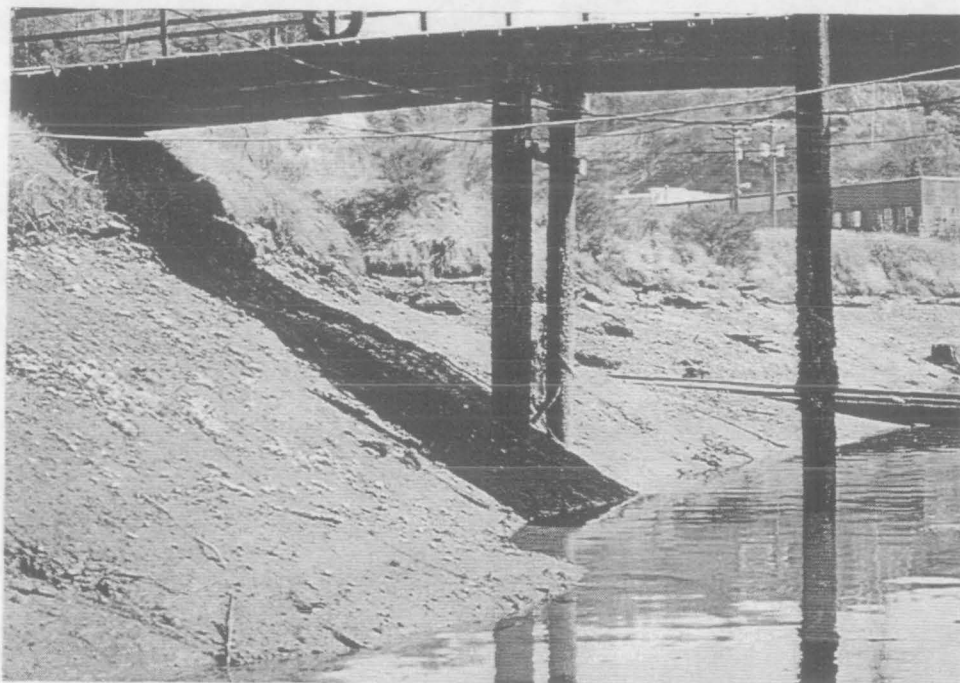
Photo was taken at an estimated tidal height of -0.5 foot

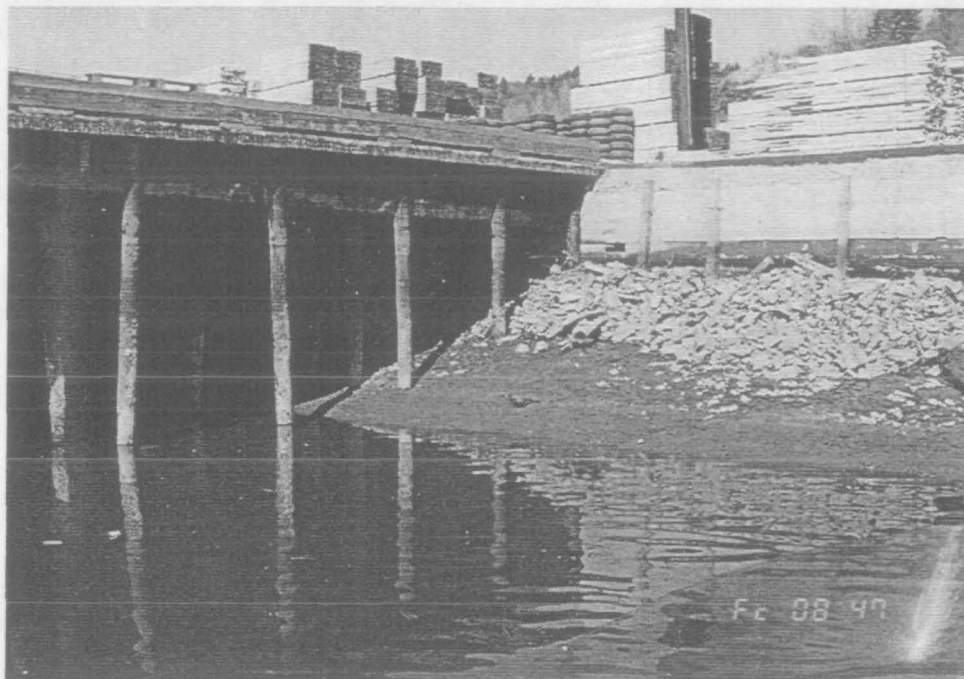
Photo was taken at an estimated tidal height of -0.5 foot

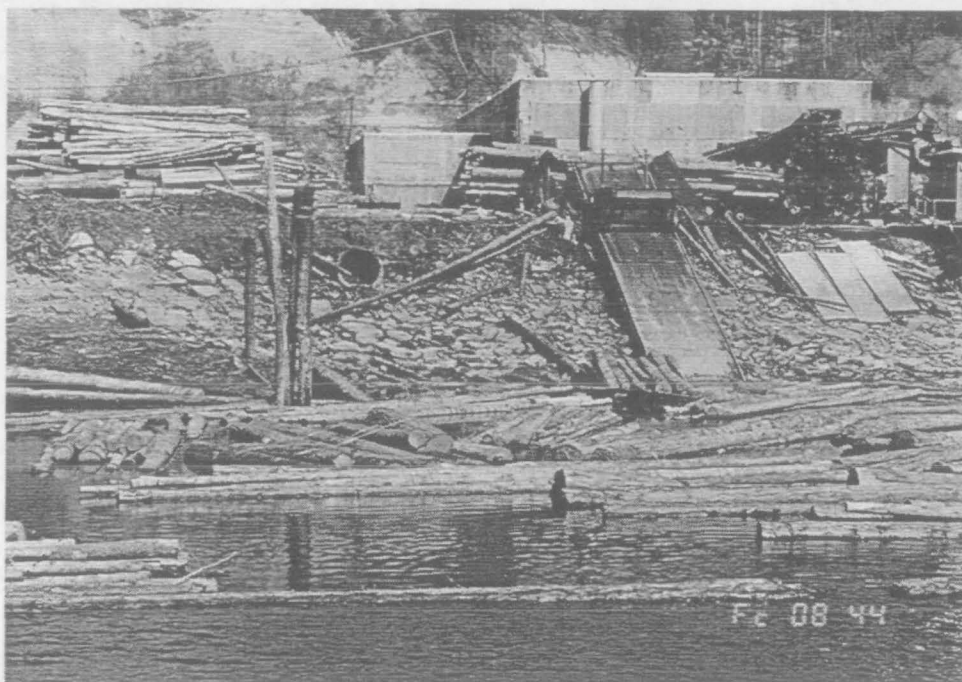
The sampling area extends behind the dock in the processed lumber portion of the facility. The length of the composite area is approximately 480 feet. There are three listed outfall pipes in the sample composite area (TPCHD No. 821, 822, 823). The top of the bank is bulkheaded in some areas and the middle portion is rip-rapped with concrete rubble. The lower intertidal area consists of cobble, gravel, sand, and mud. Problem chemicals found at low levels associated with the upland operation of the facility include: phenols, phthalates, acetone, chloroform, and toluene (Dunniho 1991). Surface runoff from the upland site contained pentachlorophenol (Gooding 1991b, Coleman 1992c). At one time a portion of the sample composite area was used for boat repair (PRC 1993).

Samples for compositing will be collected from the following ten locations along a single horizontal transect between 0' to +4' MLLW.

No.	Distance	No.	Distance
1	30	6	278
2	71	7	311
3	124	8	366
4	162	9	424
5	215	10	468

Photo was taken at an estimated tidal height of -0.8 foot

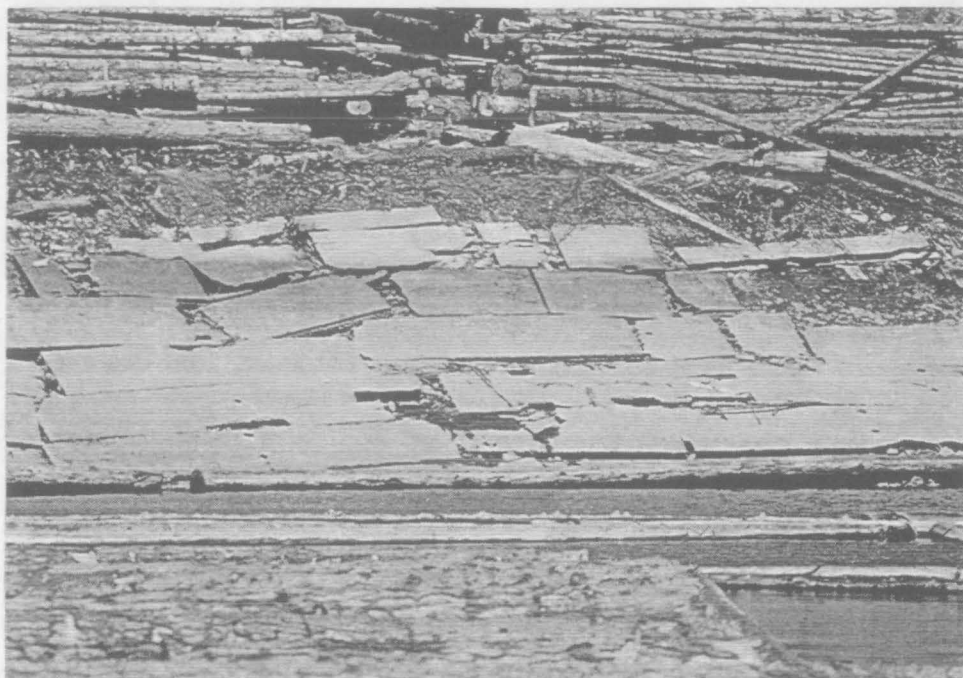
The sampling area encompasses the area surrounding a large outfall pipe (TPCHD No. 40) and a smaller pipe listed as TPCHD No. 41. The length of the composite area is approximately 200 feet. The upper portion of the bank appears to be fill from log debris, while the middle portion consists of clay, cobble, gravel and sand. The lower intertidal area was not visible due to log rafts. Based on available studies, problem chemicals found in the vicinity of the outfall pipe include PAH's and phenols (Gooding 1991b, Coleman 1992c).

Samples for compositing will be collected from the following four locations along a single horizontal transect between 0' to +4' MLLW.

No.	Distance	No.	Distance
1	6	3	146
2	92	4	172

Photo was taken at an estimated tidal height of -0.8 foot

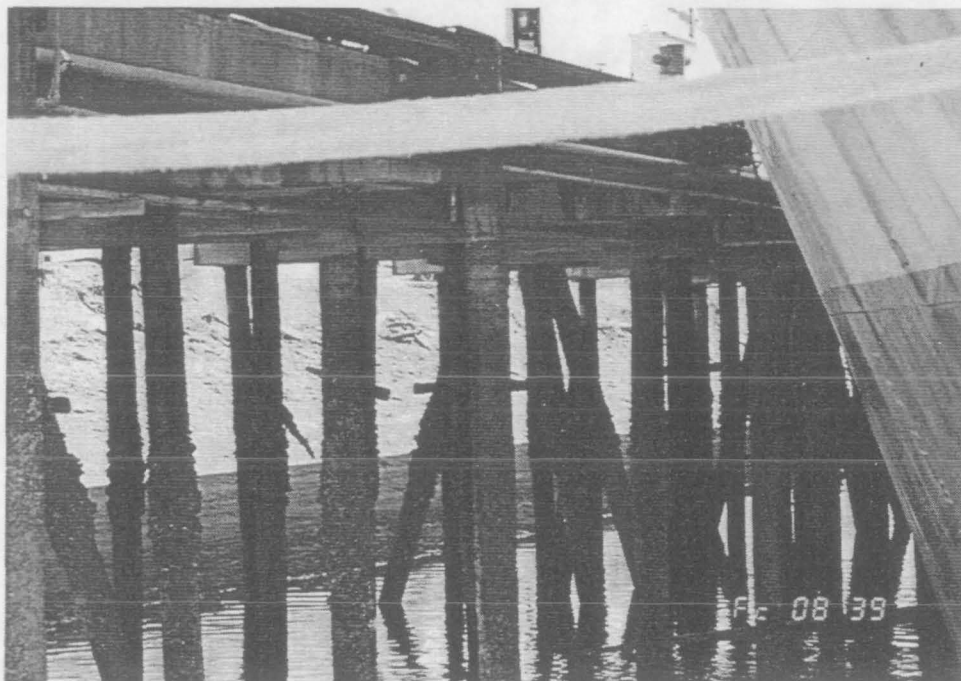
The sampling area encompasses the large boat ramp at the east end of the property. The length of the composite area is approximately 200 feet and is bisected by the ramp. There is one listed outfall pipe (TPCHD No. 815) at the corner of the pier adjacent to the boat ramp. The bank along both sides of the ramp appears to be sand and mud. Based on available studies, problem chemicals which are suspected to be associated with this portion of the site include: methyl ethyl ketone, trichloroethylene, arsenic, copper, lead, and zinc (Ecology and Environment 1979, Gooding 1989).

Samples for compositing will be collected from the following four locations along a single horizontal transect that runs along the waterway shoreline and crosses the boat ramp between 0' to +4' MLLW.

No.	Distance	No.	Distance
1	6	3	130
2	86	4	160

Photo was taken at an estimated tidal height of -1.0 foot
